# Reconnaissance Report on Damage of Bridges in 2021 Maduo, China, Earthquake

Conference Paper · January 2022

Jingcheng Wang, Zhongguo Guan

A powerful earthquake occurred in Maduo, Qinghai Province, China, on May 22, 2021. Bridges at the earthquake-stricken area were damaged or even collapsed. Post-earthquake field investigations of damaged bridges were conducted by the authors during May 28-30, 2021. This is a reconnaissance report on the damage to two typical girder bridges near the epicenter as well as possible damage mechanisms. It is found that the velocity pulse effect of near-fault ground motions could trigger excessive longitudinal displacements and severe pounding of superstructures of long multi-span girder bridges. Abutments could effectively reduce longitudinal seismic damage of short girder bridges through providing sufficient translational restraints.

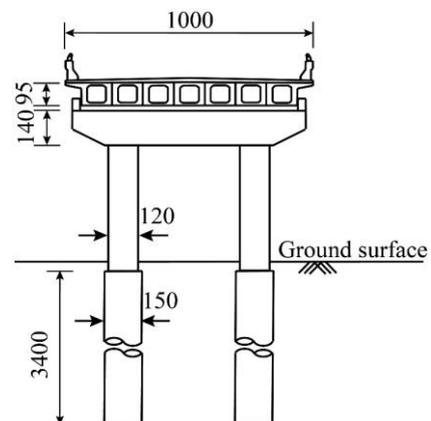
Figure 4. Yematan Second Bridge (Unit: cm)

eleven  $4 \times 20$  m girder bridges and the downstream bridge is 900-m in length comprising nine  $5 \times 20$  m girder bridges. Figure 4 illustrates typical bent of Yematan Second Bridge. Prestressed concrete (PC) hollow slab-girder is connected to the continuous deck and simply supported by reinforced concrete (RC) two-column bents with extended pile-shafts through elastomeric bearings. The ground soil consists of loose to dense sandy soils, the upper layer of which are seasonally frozen.

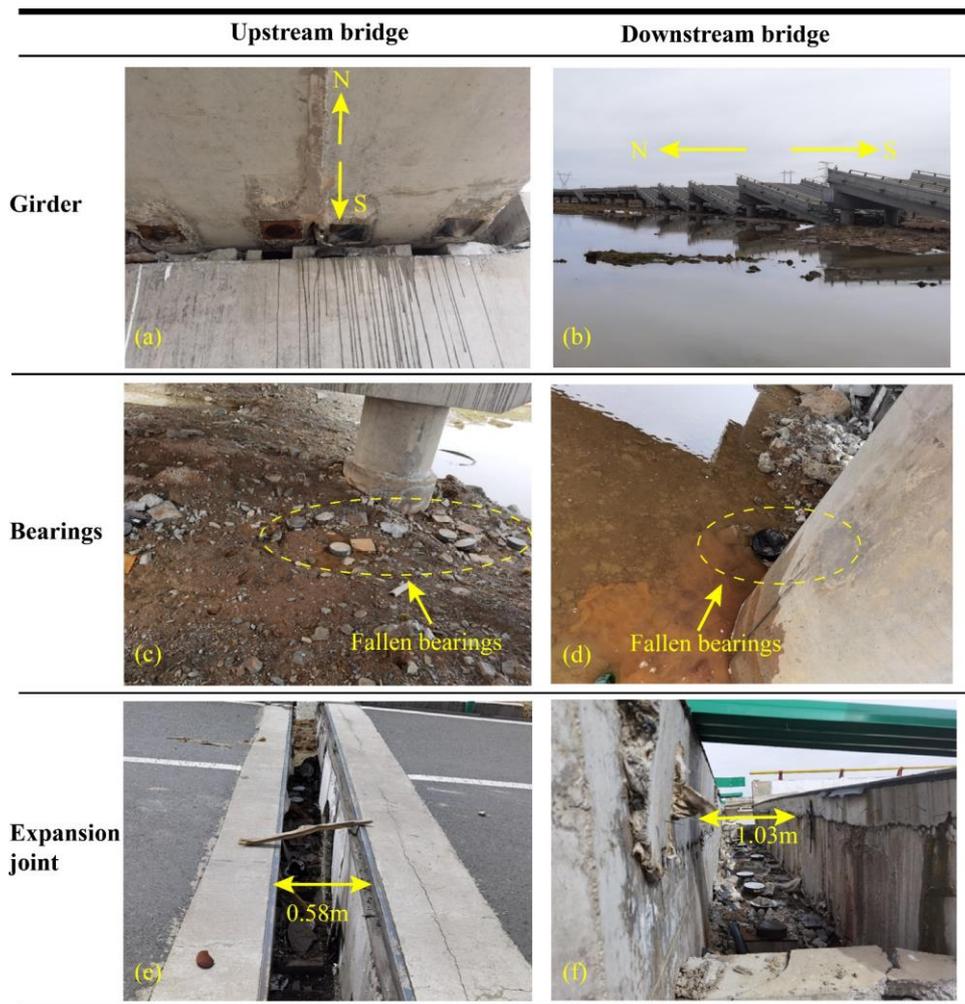
In the longitudinal (N-S) direction, different damage features were observed in girder bridges near the south end (south abutment) and north end (north abutment) of Yematan Second Bridge. Figure 5 shows the damage observed near the south abutment. It was seen that south ends of the upstream bridge girders were about to fall from the

support (Figure 5(a)) while south ends of seven downstream bridge girders had fallen to the ground (Figure 5(b)). Bearings supporting these girders were moved out from their positions and fell to the ground (Figure 5(c)(d)). The gap width of expansion joints between the south abutment and girder in the upstream bridge and downstream bridge is up to 0.58 m and 1.03 m (Figure 5(e)(f)), respectively. Other components of girder bridges near the south abutment, e.g., pavement and substructures, kept almost intact. Clearly, Yematan Second Bridge suffered extremely large longitudinal (northward) displacements of bridge decks.

Figure 5. Damage observed in the longitudinal direction of girder bridges near the south abutment

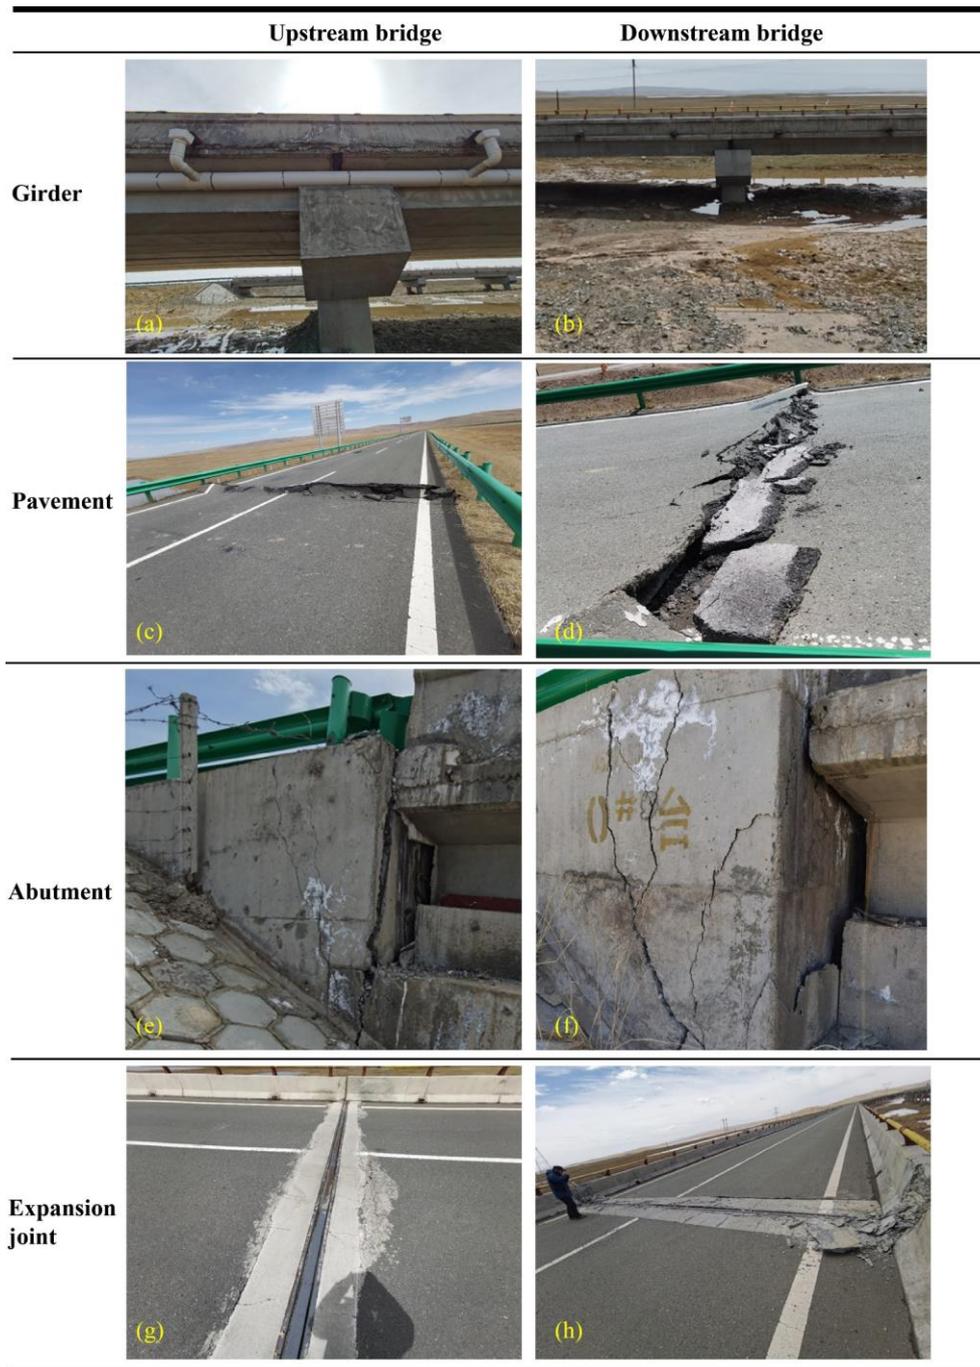
Figure 6 shows the damage observed near the north abutment. Seen from Figure 6 (a)(b), the deck displacement near the north abutment is much smaller than that near the south abutment.

Figure 6. Damage observed in the longitudinal direction of girder bridges near the north abutment

Additionally, it was found that from the north to south, deck displacements of girder bridges gradually increased. Figure 6(c)(d) display the damage to pavement at the end of north abutment approach slabs. The extrusion deformation of the pavement was about 0.3 m, which was induced by collisions between the girder and north abutment. Such severe collisions also caused concrete cracking and spalling of the north abutment (Figure

6(e)(f)). Besides, collisions occurred between adjacent girders bridges, leading to the closure of expansion joints and concrete cracking/spalling of pavement near them, as shown in Figure 6(g)(h).

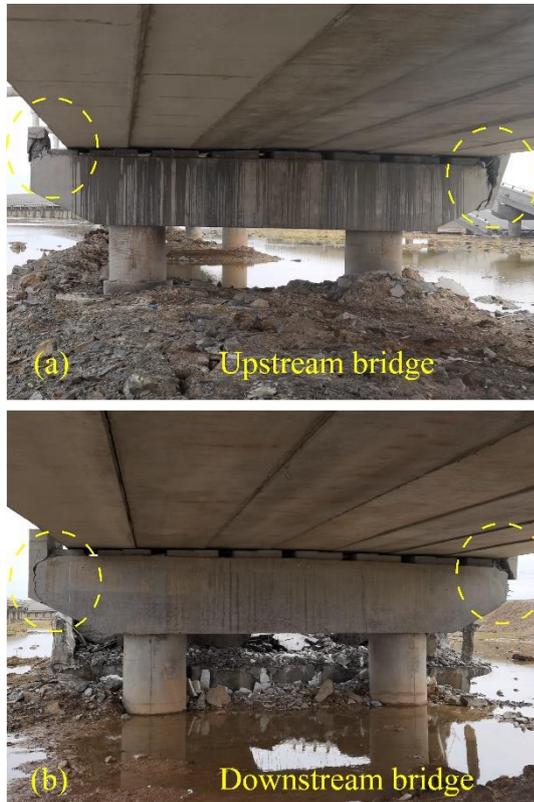
In the transverse (E-W) direction, side blocks were installed at both sides of girders to restrict their lateral translations. Figure 7 displays the post-earthquake state of side blocks. Cracking and

spalling of concrete implied that the side block worked during the earthquake. No other damage was found in this direction. Apparently, damage in the transverse direction was less severe than that in the longitudinal direction.

Figure 7. Damage to side blocks

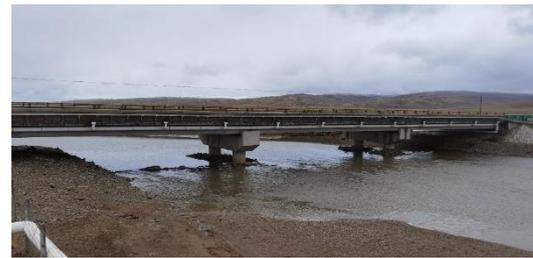
Figure 8 shows the post-earthquake state of Heihezhong Bridge. It was found that the bridge was still serviceable without collapse of spans and severe damage of bridge components. Figure 9 displays damage observed in Heihezhong Bridge. Merely slight concrete cracks were found at expansion joints, abutments and side blocks

Figure 8. Post-earthquake state of Heihezhong Bridge

As for Heihezhong Bridge, the satisfying seismic performance should be attributed to the translational restraints provided by abutments rather than the isolation effect of high damping rubber bearings. More specifically, it was found that the gap width of expansion joints between abutments and girders were quite small. In this regard, the longitudinal behaviour of the short three-span bridge was similar to that of integral bridges, i.e., the superstructure basically kept synchronous movement with the ground. In other words, relative displacements of girders were negligible and contributions of isolation bearings were thus quite limited. When abutments and backfill can overcome the inertial force of the superstructure, the longitudinal seismic demands of bridges were very small.

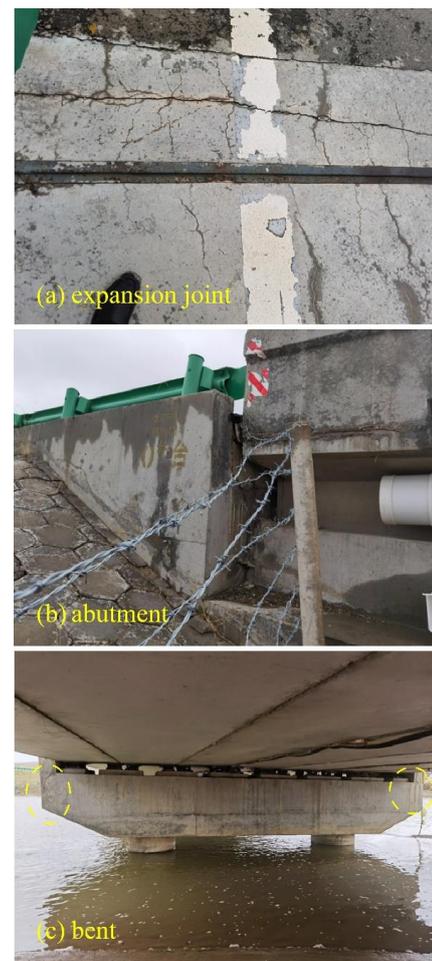
Figure 9. Damage of Heihezhong Bridge

induced by minor collisions occurred in the longitudinal and transverse direction. Bridge bents were almost intact. In general, Heihezhong Bridge behaved satisfactorily during the earthquake.

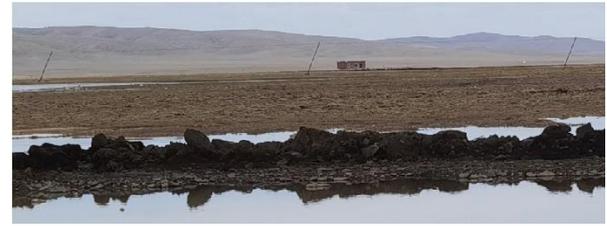
pulses may instantaneously produce significant southward ground displacements, leading to northward relative displacements of bridge girders. Figure 10 shows the post-event state of telegraph poles near Yematan Second Bridge. Tilted telegraph poles indicated significant permanent ground deformations, which generally resulted from much larger instantaneous ground deformations. Due to translational restraints provided by north abutments, girders near north abutments suffered less displacements but more severe pounding damage. The displacements of girders near the south abutment were extremely large that completely exceeded the displacement capacity of bearings and the seat length of girders, resulting in unseating of girders. Compared to the downstream bridge, the upstream bridge is less damaged. Different magnitudes of damage between two bridges may be attributed to the difference of bridge deck length (i.e., 80 m vs. 100 m) and difference of ground motion inputs due to the local soil liquefaction, which was observed at regions between the upstream bridge and downstream bridge.

Figure 10. Tilted telegraph poles near Yematan Second Bridge
